**PRELIMINARY FISHERIES RESOURCES IMPACT ASSESSMENT FOR THE PROPOSED  
CLOVERDALE LIGHT RAIL TRANSIT BRIDGE  
OVER THE NORTH SASKATCHEWAN RIVER**

PRELIMINARY FISHERIES RESOURCES IMPACT ASSESSMENT FOR THE PROPOSED  
CLOVERDALE LIGHT RAIL TRANSIT BRIDGE  
OVER THE NORTH SASKATCHEWAN RIVER

*Prepared by:*  
Pisces Environmental Consulting Services Ltd.  
Red Deer, Alberta

April 2013

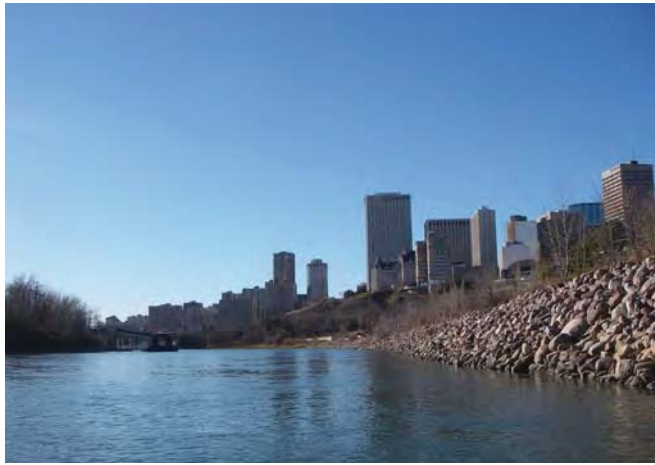
Plate 1- Armored (A2) habitat. Photo facing upstream from 0.2 km upstream of Cloverdale footbridge.

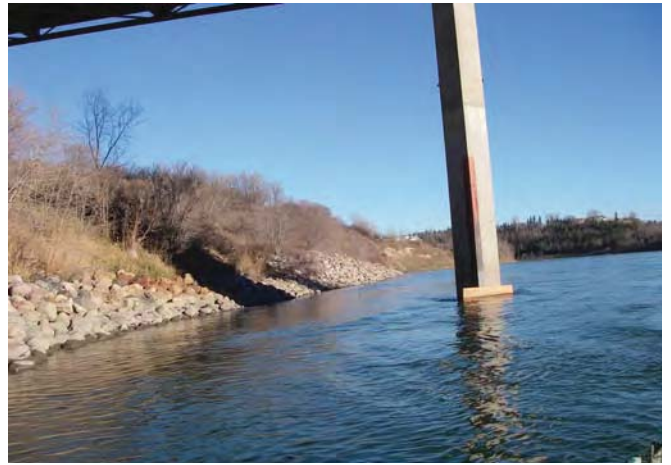
Plate 2.- Armored habitat (A2) on RUB immediately adjacent to Cloverdale footbridge (facing downstream).

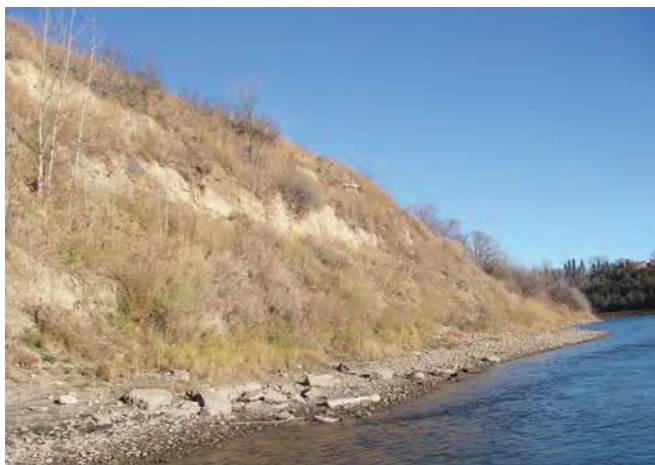
Plate 3 - Armored habitat (A1) along RUB 0.4 km downstream of Cloverdale Bridge.

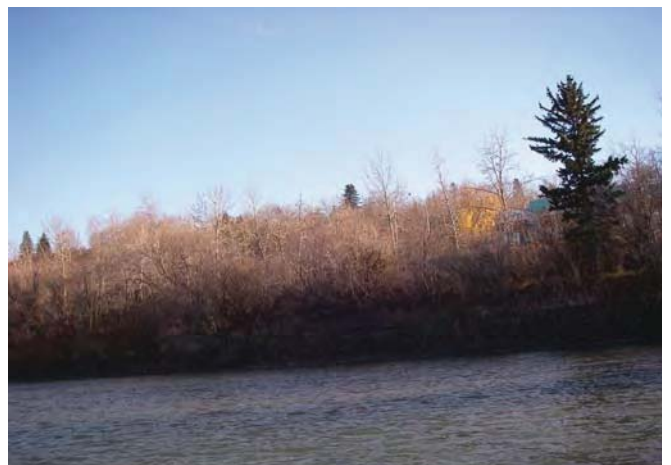
Plate 4 - Transition of RUB Bank 0.6 km downstream of Cloverdale Bridge from depositional habitat (D1) to erosional habitat (E5).

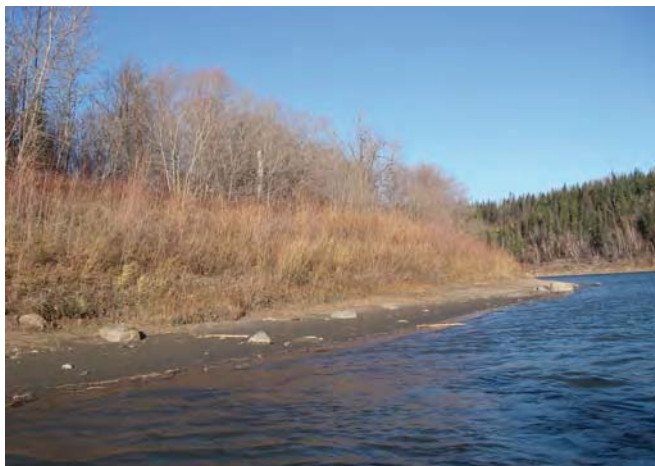
Plate 5 - Depositional habitat (D2) along RUB 1 km downstream of Cloverdale bridge.

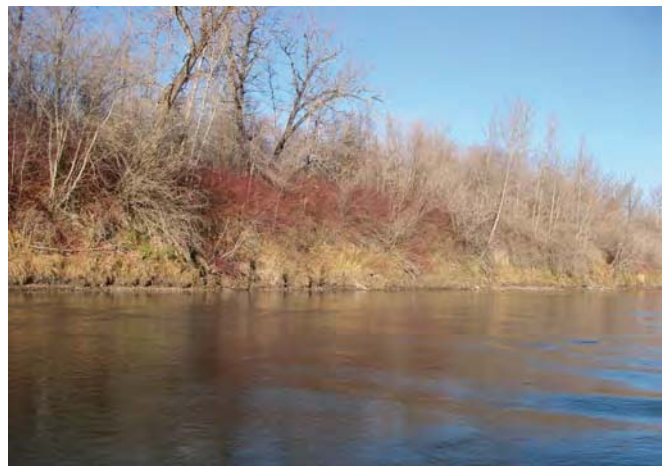
Plate 6 - Erosional habitat (E5) along RUB 1.4 km downstream of Cloverdale bridge.

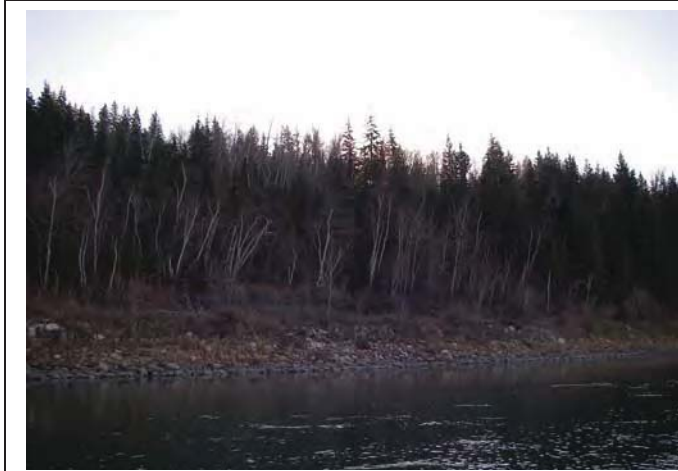
Plate 7- Armored habitat (A2) on LUB approximately 1.4 km downstream of Cloverdale Bridge.
