NORTHWEST LRT - 137 AVENUE STATION

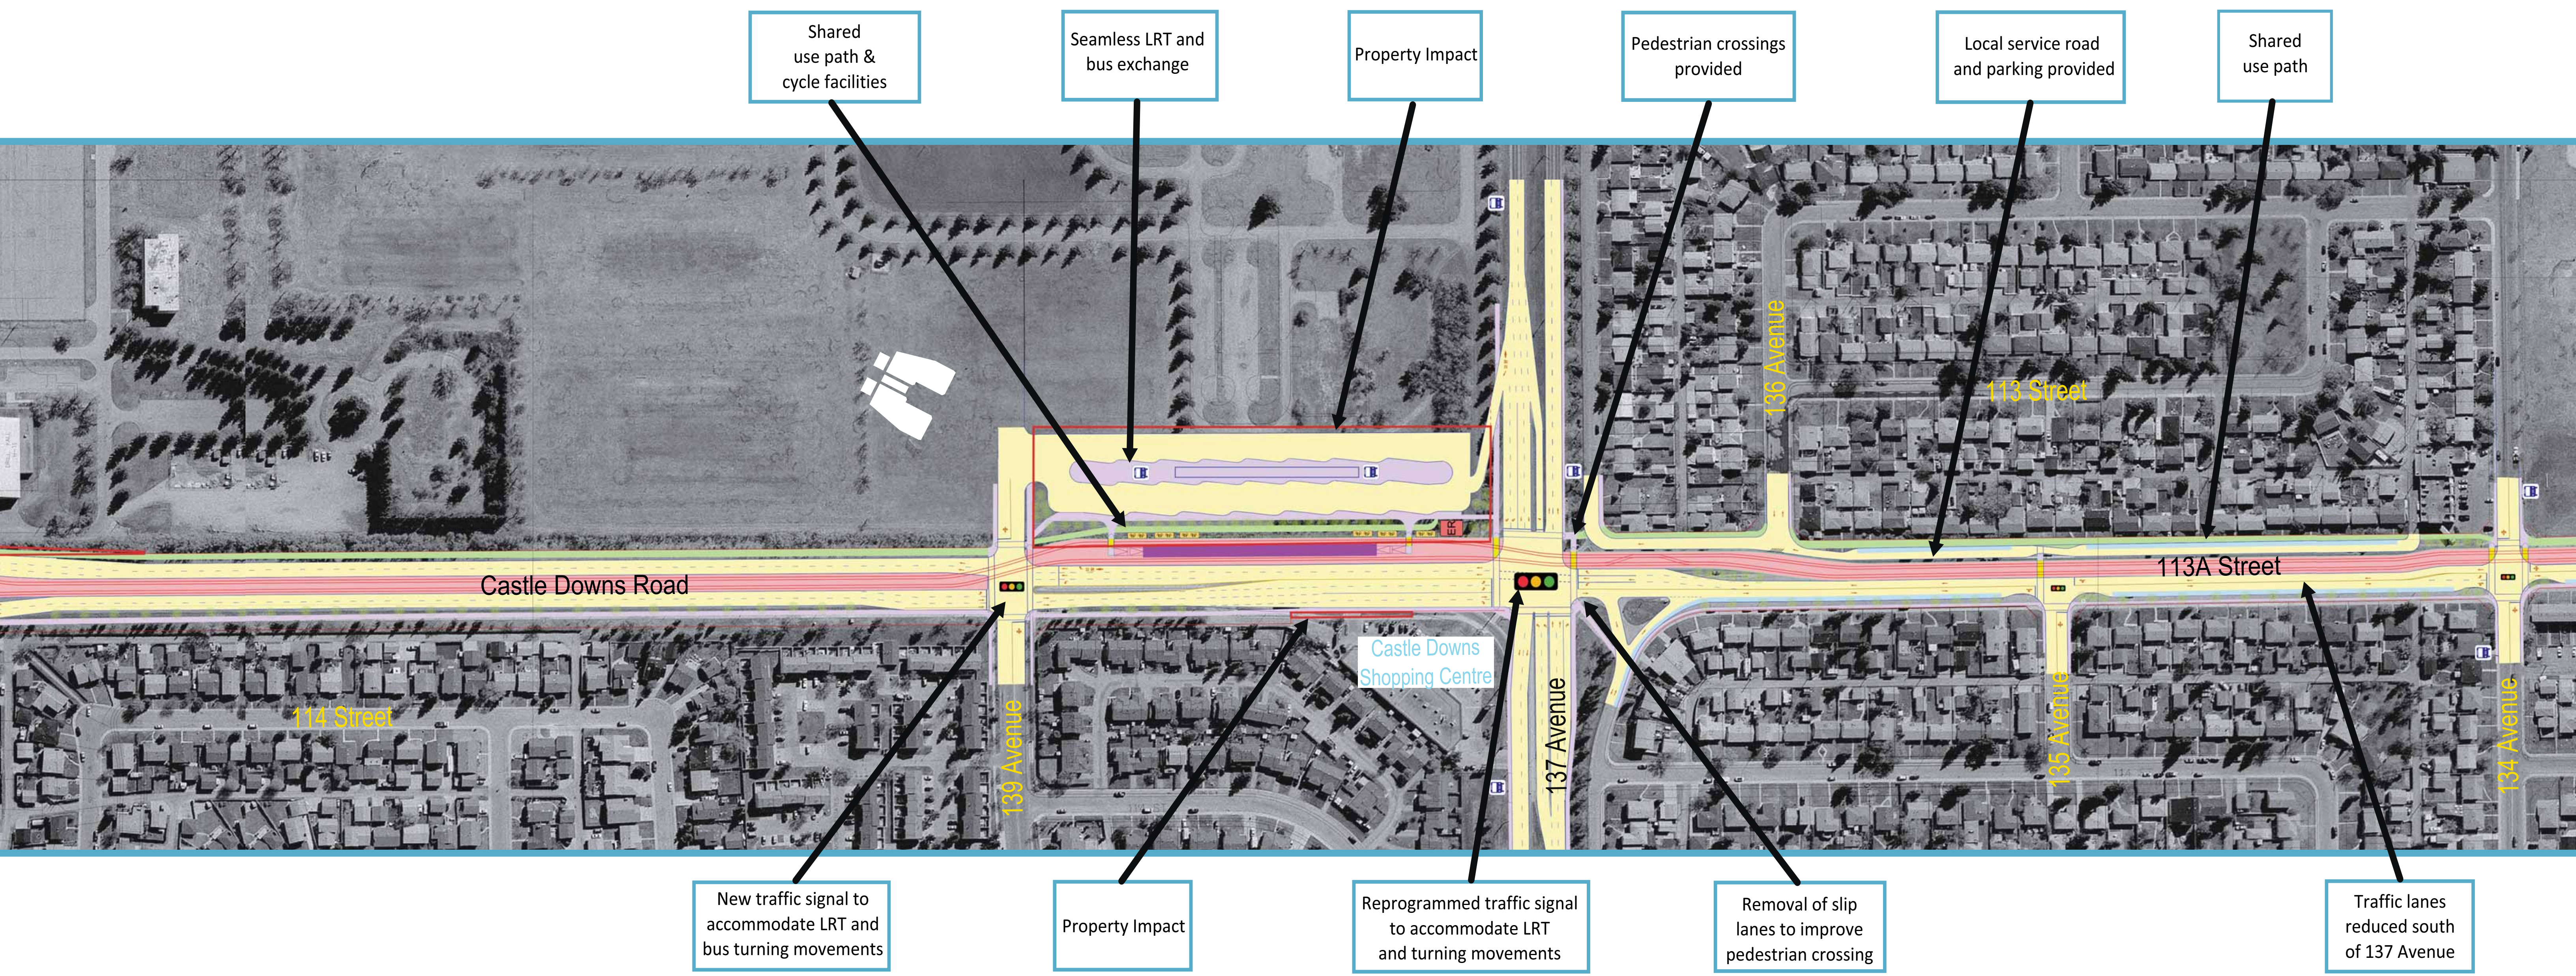
Shared use path & cycle facilities

Seamless LRT and bus exchange

Pedestrian crossings provided

Local service road and parking provided

Shared use path

New traffic signal to accommodate LRT and bus turning movements

Reprogrammed traffic signal to accommodate LRT and turning movements

Removal of slip lanes to improve pedestrian crossing

Traffic lanes reduced south of 137 Avenue
